Date: October 19, 2022

From: Timothy Gross, Senior Project Manager, Civil West Engineering Services, Inc.

RE: **Little Log Church and Museum Condition Assessment and Rehabilitation Recommendations**  
Civil West Project Number: 3401-006

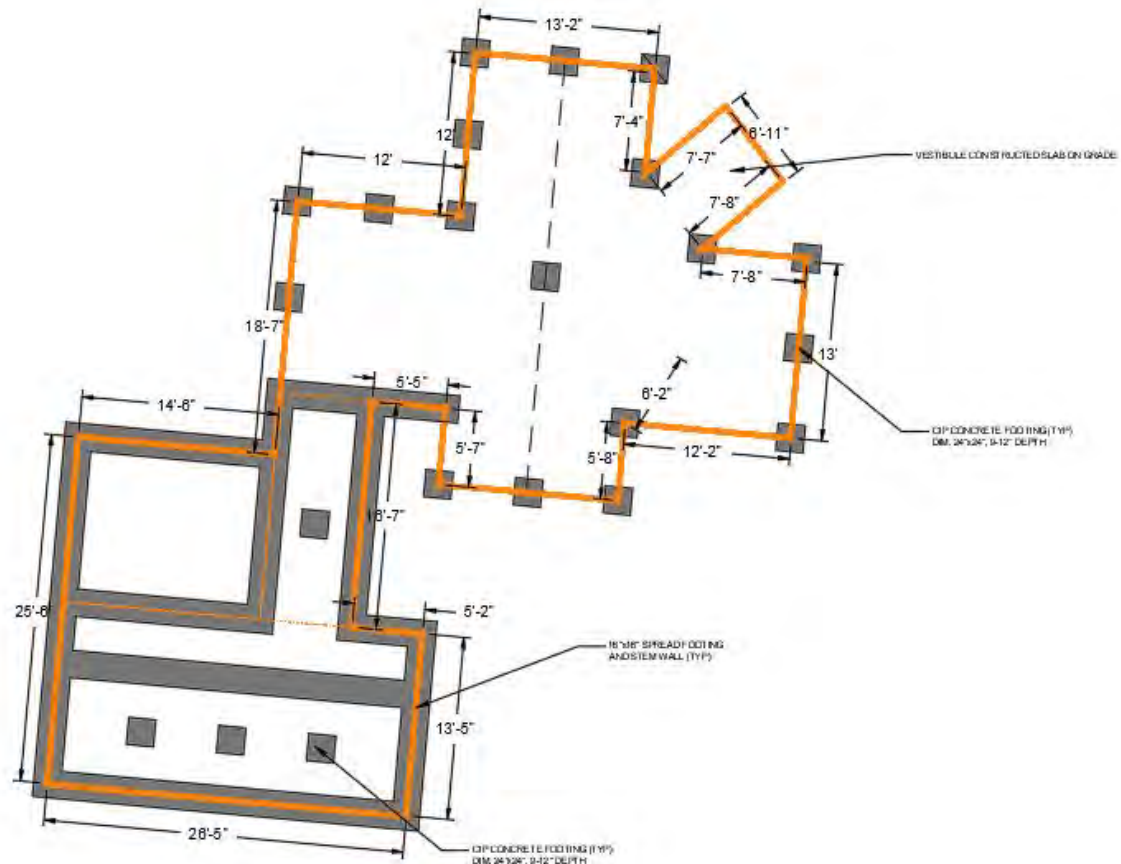
Figure 2 - FOUNDATION PLAN

The stem wall spread footing foundation appears in good condition. There is no evidence of settlement nor cracking. A foundation plan for the building is included as Figure 2 and in Exhibit A, Figure 2.

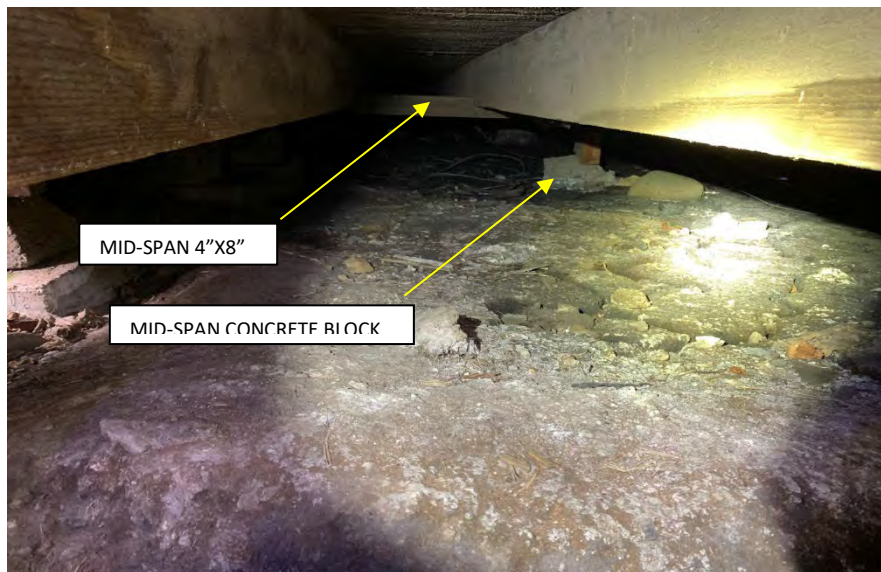
The church structure is constructed with a rough cut 4"x8" (true dimension) timber perimeter frame which supports the rough cut 2"x10" floor joists and the log walls. The timber frame is supported on cast-in-place concrete foundation blocks. The concrete foundation blocks average 24" square in dimension and varied from 9" to 12" in depth. It appears the foundation blocks were poured directly on native soil. The outside of the timber frame is clad in rough cut 2"x12" cedar which is backfilled to the top of the cladding with 2" clear river rock. Block footings appear to be located at all inside and outside corners, mid-wall, and one at mid-span on the north-south centerline of the structure. See Figures 3, 4 and 5.

The concrete block foundations do not appear original to the structure. There is evidence of original concrete block foundations that were modified/replaced at a later date with the current block foundations. The block foundations appear in reasonable condition and there should be no reason for their replacement unless future structural framing changes necessitate it.

Figure 3- CIP CONCRETE BLOCK FOOTING - N to S MID-SPAN, FACING WEST

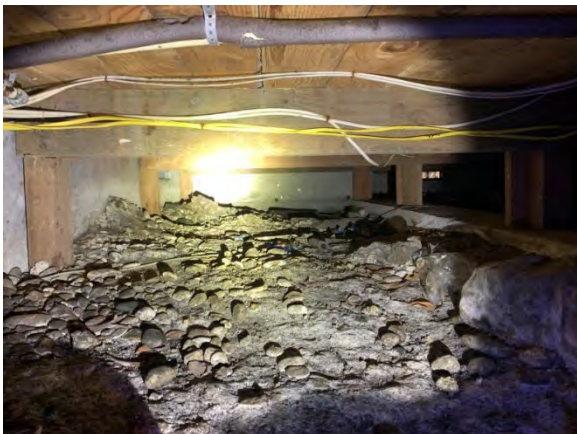
The museum/entry/bathroom foundations are 16" high cast-in-place concrete stem walls with 16" spread footings. The floors are supported below the museum and entry additions by 4"x8" (nominal dimension) beams with end and mid-span 4"x4" posts. The bathroom addition floor is supported with 2"x8" treated ledger boards bolted to the stem wall. Floor joists are 2"x8" at 16" on center hanging from the ledger board via joist hangers. See Figures 8 and 9.

*Figure 8- MUSEUM AND ENTRY  
FOUNDATION AND FLOOR SUPPORT*

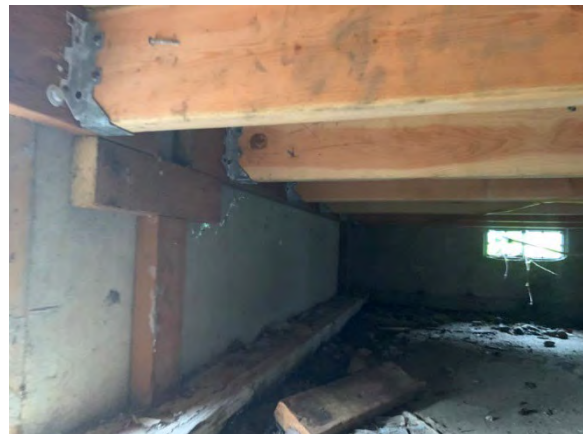
*Figure 9 - BATHROOM ADDITION  
FOUNDATION AND FLOOR SUPPORT*

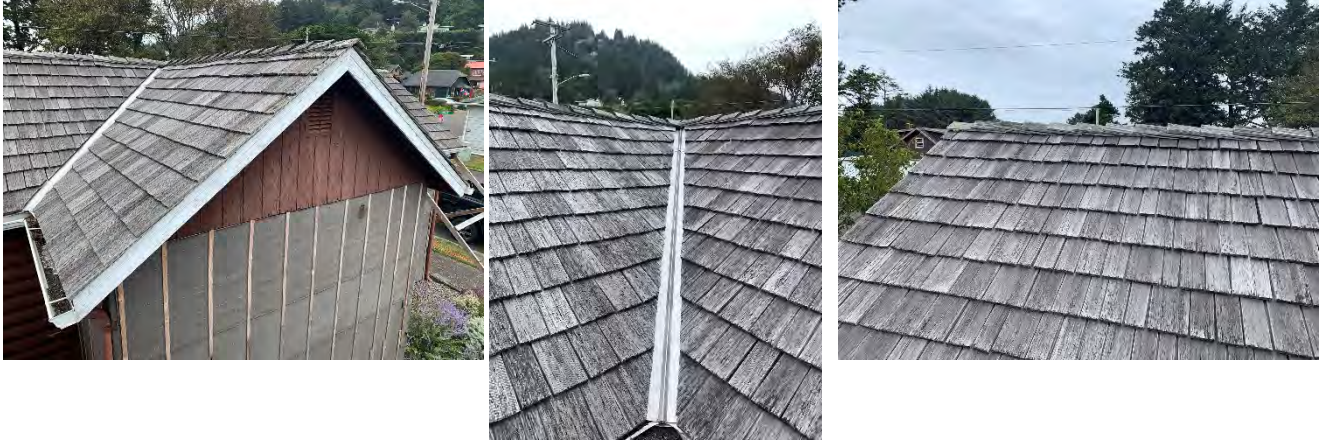
The church is roofed with cedar shakes with stainless steel flashing. See Figure 9. It appears the roof has been replaced within the last 10 years or so. The roof is in good condition. The building is equipped with aluminum gutters and they appear in good condition. Roof decking is rough sawn 1"x8" planks overlaid with tar paper when the recent cedar roof was installed. There is no evidence of rot and the planking is in good condition. The roof structure is constructed of rough cut 2"x4"'s at 24" on center. There is no ridge beam. The roof trusses are not sagging nor cracked and appear in good condition. 1"x6" planks are nailed to the underside of the trusses as sheetrock nailers. See Figure 11. There is no insulation in the attic space. The gables are covered in the original cedar board and batten. This wood is beginning to rot and should be replaced. It appears the soffits were replaced with the roof and are in good condition.

*Figure 10- CHURCH CEDAR SHAKE ROOF*

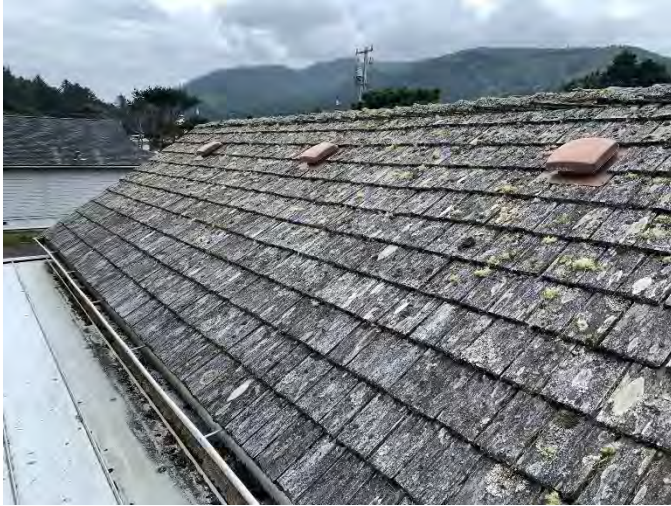
The museum building is roofed in cedar shakes which appear to date from the original construction. See Figure 10. No shakes are broken nor missing and structurally the roof appears in good condition. However, the cedar is infested with lichen and moss growth which is slowly disintegrating the wood. See Figure 13. The City should consider some preventive maintenance including moss preventative treatments to preserve the cedar shakes. There was no apparent access to the interior of the roof therefore no assessment was conducted on the roof structural framing. The building is equipped with aluminum gutters and they appear in good condition.

*Figure 12- MUSEUM CEDAR SHAKE ROOF*

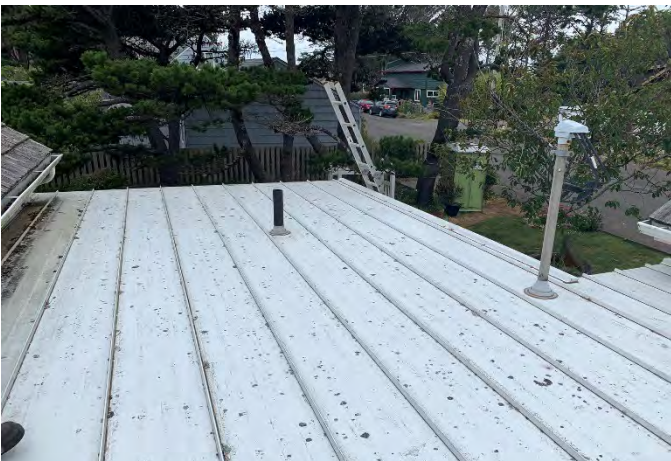
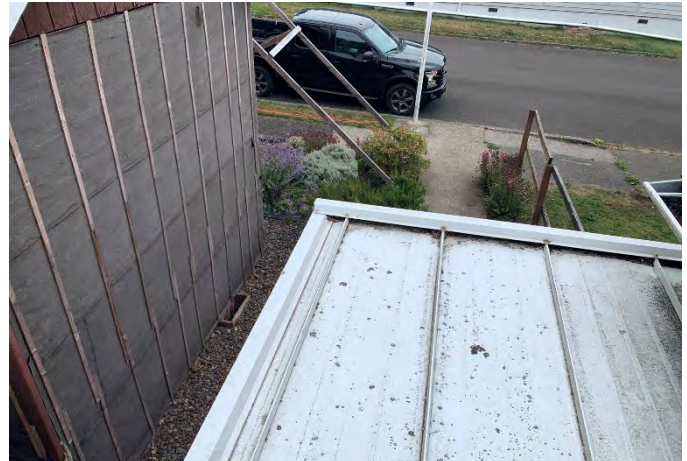
The roof over the entryway/bathroom between the museum and church is standing seam metal. See Figure 14. Based upon foundation observations, the entryway was constructed at the same time as the museum building and the bathroom was built sometime later. However, the standing seam roof over the two additions is continuous therefore the roof must have been constructed at the time of the bathroom addition. The metal roof slopes slightly toward the west. The roof is in good condition with no signs of joint separation nor water intrusion. There are two roof penetrations, one for the bathroom drain vent and another for the electrical service mast. Boots for both penetrations are in good condition.

*Figure 14- ENTRYWAY/BATHROOM STANDING SEAM METAL ROOF*

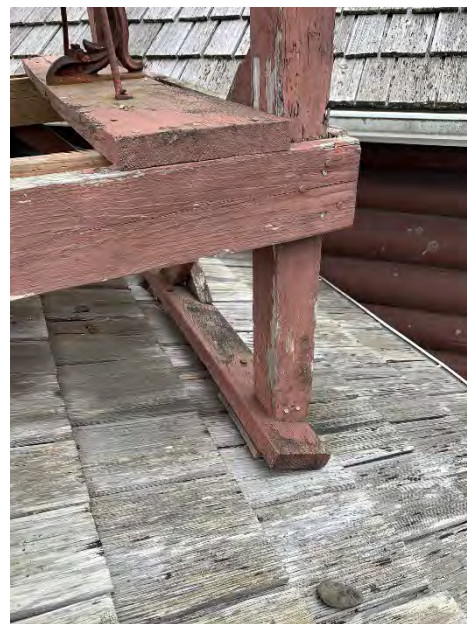
The vestibule where the main entrance to the church is located is roofed in cedar shakes. The roof of the vestibule appears the same age as the roof from the church and was likely replaced at the same time. The cedar shakes and soffits of the vestibule are in good condition. The bell tower appears to have been added to the vestibule roof as an afterthought. The bell tower is a separate structure that is lag bolted directly to the cedar roof shakes. There is space between the bell tower structure and cedar shakes where pine needles and other debris is trapped. It is likely that the roof will begin to rot at the interface between the two structures and possible that the roof may leak at the lag bolt locations as the bolts begin to rust and disintegrate. It is recommended that the City consider an alternate method for connecting the bell tower. Typical a structure such as this one would be connected to the structural framing on the interior of the roof, and the penetrations flashed appropriately. This would prevent the accumulation of debris and possible water intrusion due to material decay.

*Figure 15- BELL TOWER  
CONNECTION TO VESTIBULE ROOF*

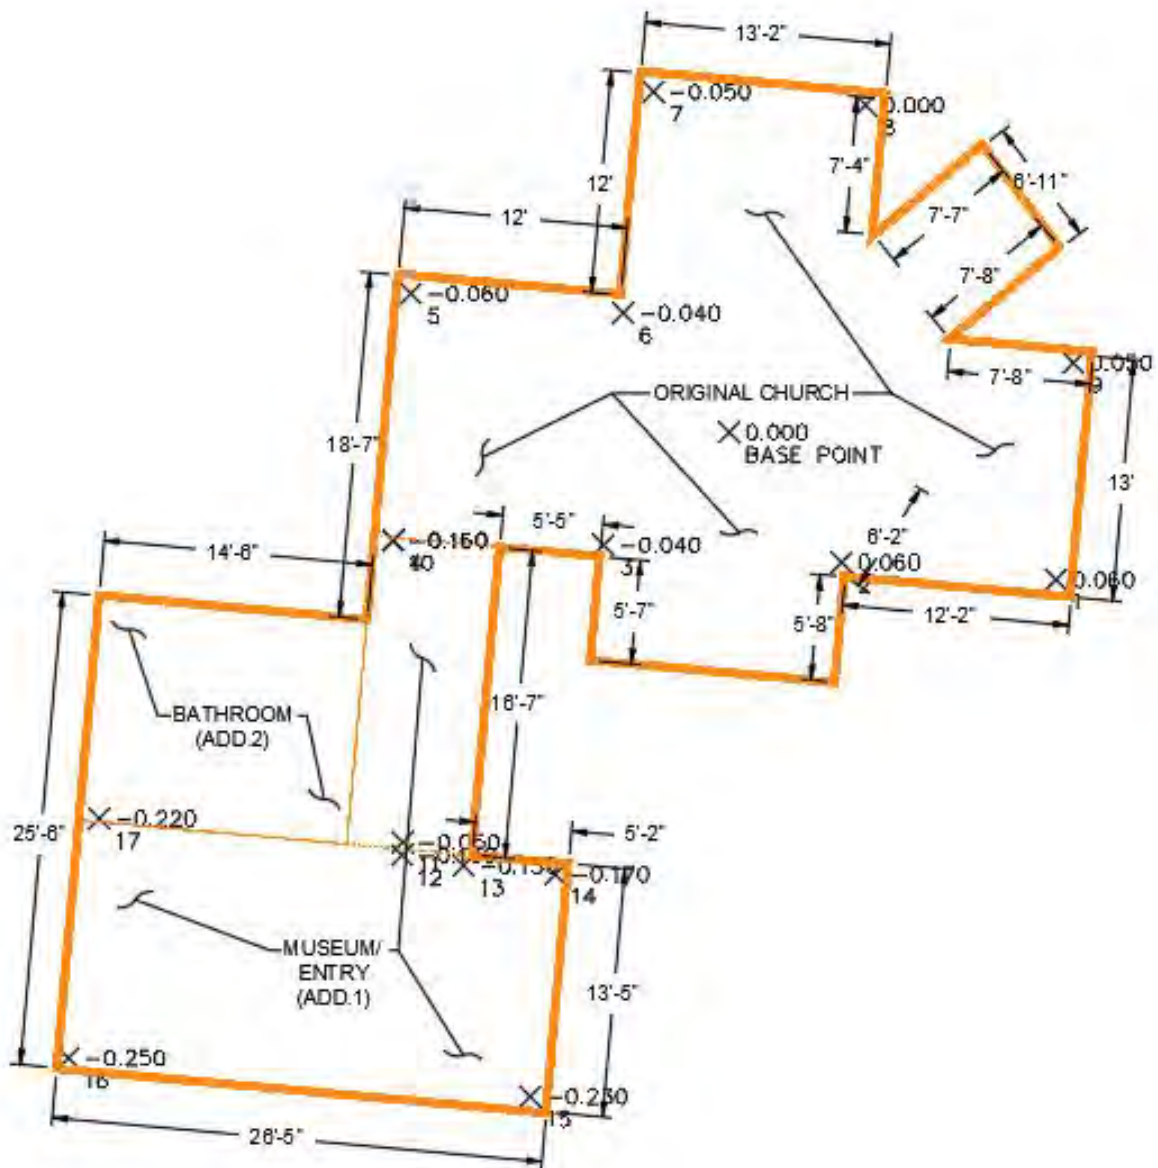
Figure 16 - FLOOR ELEVATIONS

The church, museum and entryway subflooring are rough cut 1"x6" pine planks. The subflooring of the bathroom is plywood. A survey was conducted within the building to determine if there was any settling in the floor across the structure. A level was set up in the approximate center of the church structure and the point was assigned an elevation of zero (0.00). See Figure 16 and Appendix B, Figure 3. An elevation was taken at each corner within the church structure relative to the zero-elevation located in the middle of the floor. All corners within the church were within 0.06 feet (6 hundredths of a foot) with the exception of the southwest corner adjacent to the entryway addition. This point in the floor is 0.16 feet (1-29/32") lower than the center of the floor. When the museum and entry addition was completed the foundation at this corner of the church was converted to a stem wall and spread footing. See Figure 2 and Appendix B, Figure 2. It is likely that the building settled slightly at that corner when that foundation change was made. The sheetrock on the interior of the building was replaced after the addition (date unknown) and there is no cracking or evidence of movement in the sheetrock so it is likely the settling took place immediately after the foundation was replaced and has not moved since.

The floor of the entryway and museum were also surveyed. The entryway has a dip to the south of 0.11' (1-5/16") in a distance of about 16 feet (0.7%). The museum also has a 0.12' (1-7/16") dip a distance of about 13.5 feet (0.9%) between the north and south walls. There is no evidence of foundation settlement nor any interior cracking or binding doors. Therefore, it is likely that these elevation differences are a result of framing or footing elevation variances during initial construction.

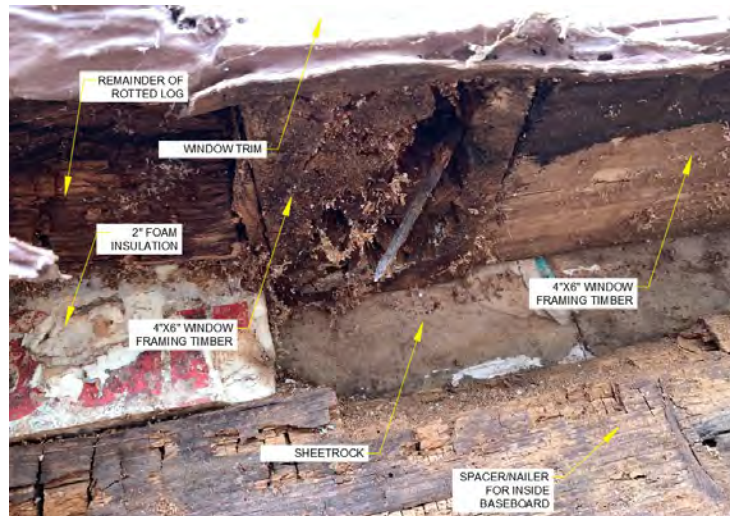
The logs on the church structure are extremely rotten in several places, in particular on the east side. See Figures 19 and 20. Large portions of the logs below and south of the east window are completely rotted away. The building is currently wrapped in tar paper and braces are supporting the north-east and south-east corners of the building. See Figure 18. Since the logs form both the structural framing and siding of the building, the braces are likely there to prevent the building from racking (tipping to the side). In typical lumber framing construction, the plywood or OSB sheathing provides protection from racking. Since this structure has no sheathing, and large portions of the logs are missing, it is possible for the building to rack in certain conditions, particularly is subjected to heavy wind loads.

Figure 19 - ROT BELOW CHURCH WINDOW - LOOKING UP

Based upon the observed condition of the building, it is recommended to replace the entire wall structure, siding, windows, and gables of the little log church, and replace only the siding of the museum. A cost estimate was prepared assuming the walls of the church will be replaced on at a time using conventional lumber framing constructed on top of the existing perimeter beam. See Table 1. It will be necessary to support the roof structure using jacks or scaffolding and the rental and installation cost for this support was considered in the cost estimate.

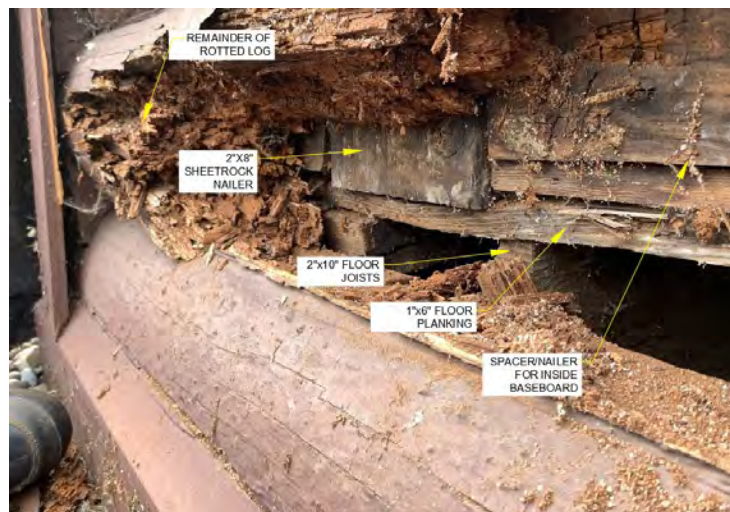
Figure 20- ROT BELOW CHURCH WINDOW, SE CORNER

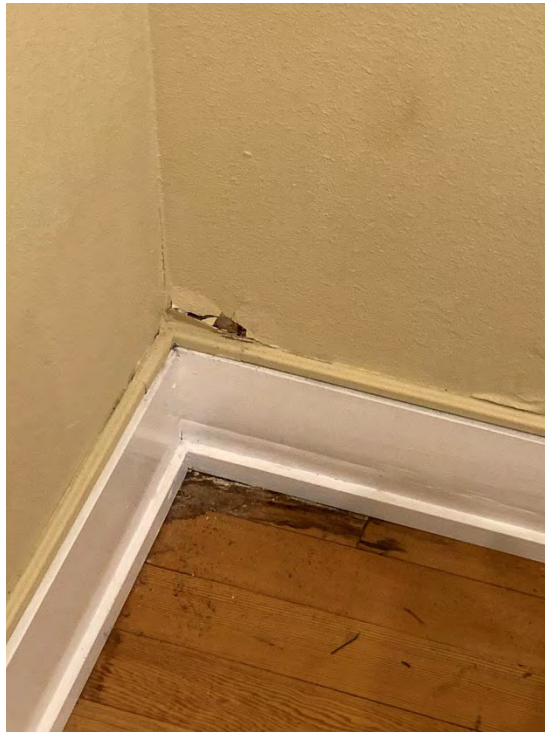
During the condition analysis we only removed the tarpaper from the east side of the building, however based upon the level of rot discovered it is likely that other faces of the church structure covered by tarpaper are also in advanced stages of rotting, even if they are not fully decayed like the east side. The sheetrock and flooring on the inside of the building was examined for water damage and/or cracking and settling. The only location where damage was evident was in the south-east corner of the structure where the sever rotting damage was discovered. Please see Figure 21. It is recommended that the City completely replace the log framing/siding. Details of the replacement and estimated costs are included in Chapter III.

*Figure 21 - WATER DAMAGE - SOUTHEAST CORNER*

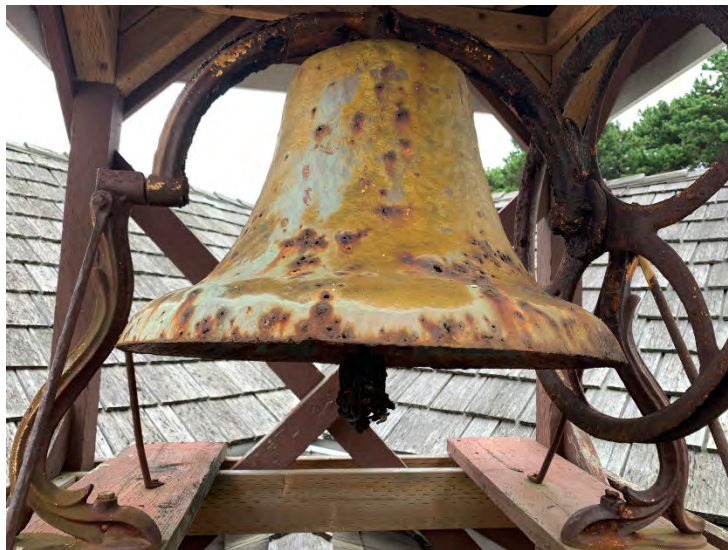
The belltower is constructed of treated wood and is roofed with cedar shingles. Please refer to section II.F for details on the bell tower mounting to the vestibule. The belltower wood is pretty weatherworn and is beginning to decay. The bell and bell framework are very pitted and rust. See Figures 14 and 22. The bell clearly can no longer be rung, but it is possible to remove the bell and have the bell and frame stripped and restored. When the walls are repaired/replaced in the church structure, it is likely that the bell tower will need to be removed. It is recommended that the structure be rebuilt and mounted to the church structure and/or vestibule in a more permanent and weather resistant fashion. See Section II.F.

*Figure 22 - BELL AND BELL TOWER*

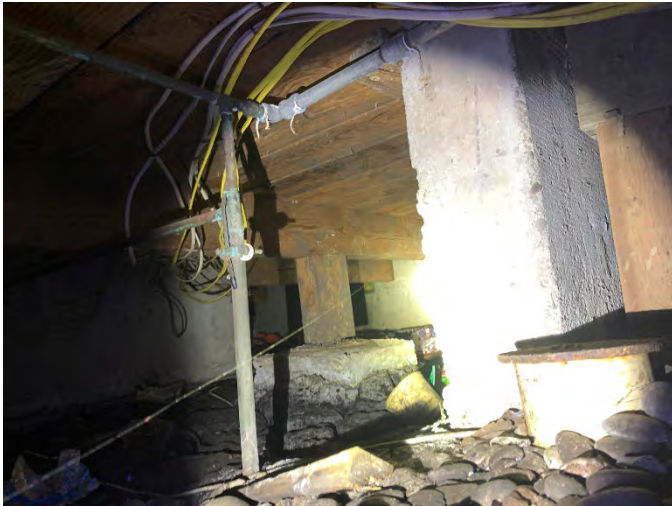
1. There were some sections of galvanized water piping that were observed in the crawl space of the bathroom/entry. See Figure 23. It is recommended that the City consider replacing the galvanized pipe with either PVC or crosslinked HDPE (PEX) pipe. The high iron and manganese content of the coastal water systems tends to calcify on the interior of iron pipe. Furthermore, the mixed metals between the copper and galvanized pipe causes the galvanized pipe to give up electrons and corrode at an accelerated rate. It is just a matter of time until the galvanized fails and it is advised to replace the pipe before that occurs and causes damage. See Figure 23.

*Figure 23- MIXED METAL PLUMBING CONNECTION  
- COPPER TO GALVANIZED*

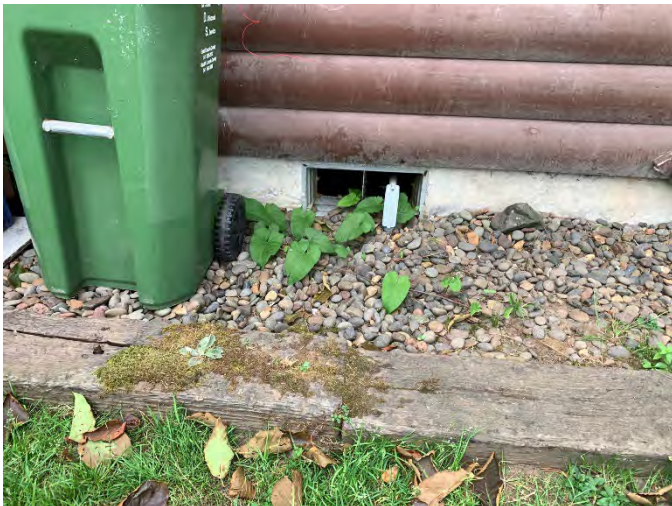
3. Some of the screens covering the crawl space are broken open and the crawlspace door is not locked and can be easily accessed. When inspecting in the crawlspace it was evident that people have been throwing trash into the open screens and using the crawlspace to sleep. See Figures 25 and 26.

*Figure 25 - CRAWL SPACE SCREEN MISSING*

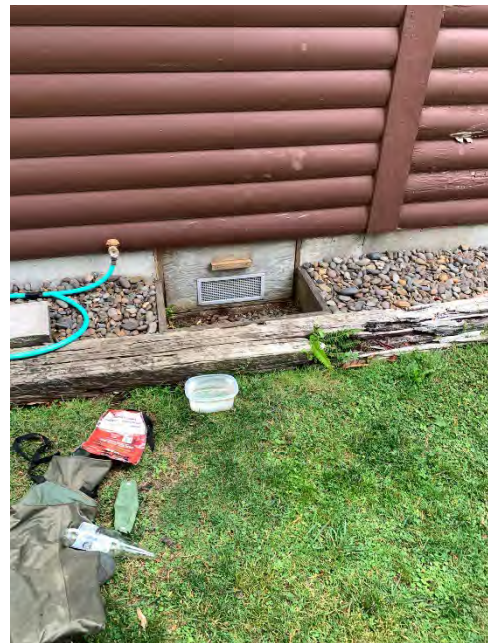
*Figure 26 - CRAWL SPACE DOOR UNLOCKED*
