Date: October 19, 2022

From: Timothy Gross, Senior Project Manager, Civil West Engineering Services, Inc.

RE: **Little Log Church and Museum Condition Assessment and Rehabilitation Recommendations**  
Civil West Project Number: 3401-006

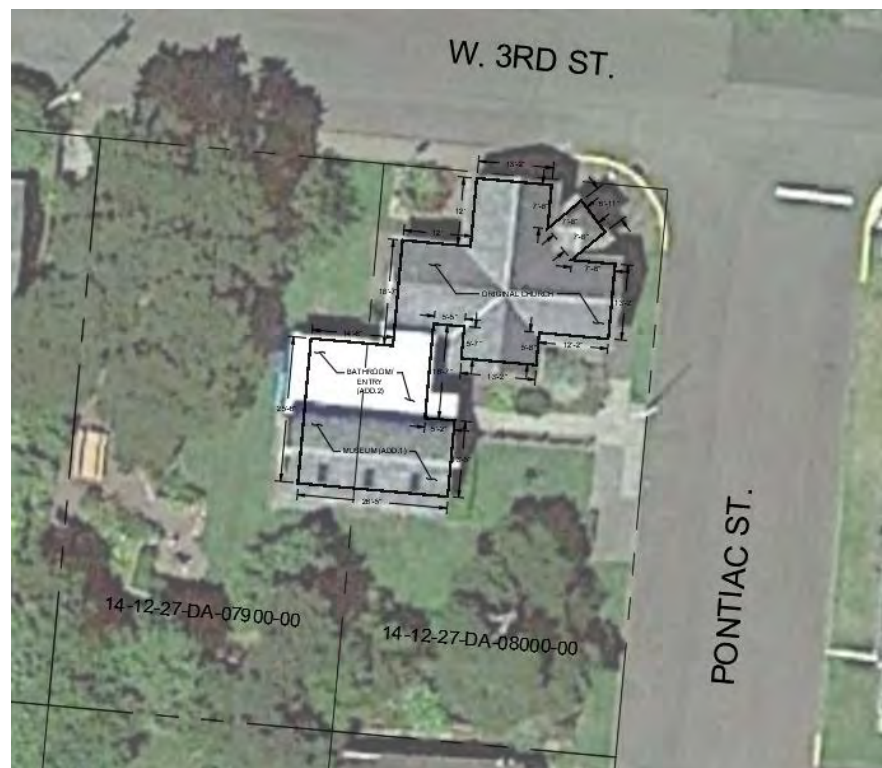
*Figure 1 SITE MAP*

the varying roof types as shown in Figure 1. The church to the north has a cedar roof, the entry/bathroom between the two structures has a white metal roof, and the museum to the south has a cedar roof. The church and museum are owned by the City of Yachats. Based upon previous evaluations, the City currently restricts use of the building because of safety concerns. The City has contracted with Civil West to conduct a condition assessment and provide recommendations and costs for rehabilitating the building. The desire of the City is to open the structure for public use and ensure that any necessary rehabilitation or replacement will resemble the existing structure as closely as possible.

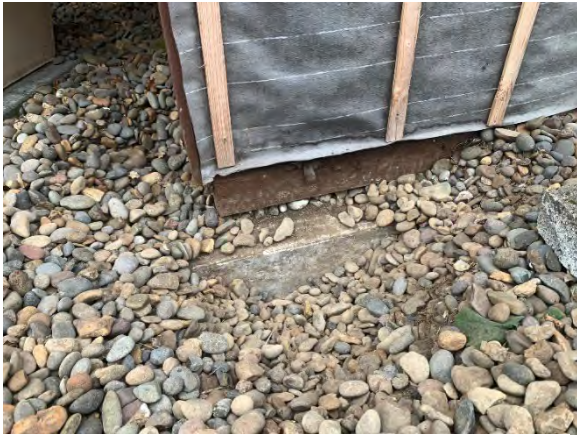
*Figure 4 -CIP CONCRETE BLOCK FOOTING -  
NE CORNER*

The church structure is constructed with a rough cut 4"x8" (true dimension) timber perimeter frame which supports the rough cut 2"x10" floor joists and the log walls. The timber frame is supported on cast-in-place concrete foundation blocks. The concrete foundation blocks average 24" square in dimension and varied from 9" to 12" in depth. It appears the foundation blocks were poured directly on native soil. The outside of the timber frame is clad in rough cut 2"x12" cedar which is backfilled to the top of the cladding with 2" clear river rock. Block footings appear to be located at all inside and outside corners, mid-wall, and one at mid-span on the north-south centerline of the structure. See Figures 3, 4 and 5.

The concrete block foundations do not appear original to the structure. There is evidence of original concrete block foundations that were modified/replaced at a later date with the current block foundations. The block foundations appear in reasonable condition and there should be no reason for their replacement unless future structural framing changes necessitate it.

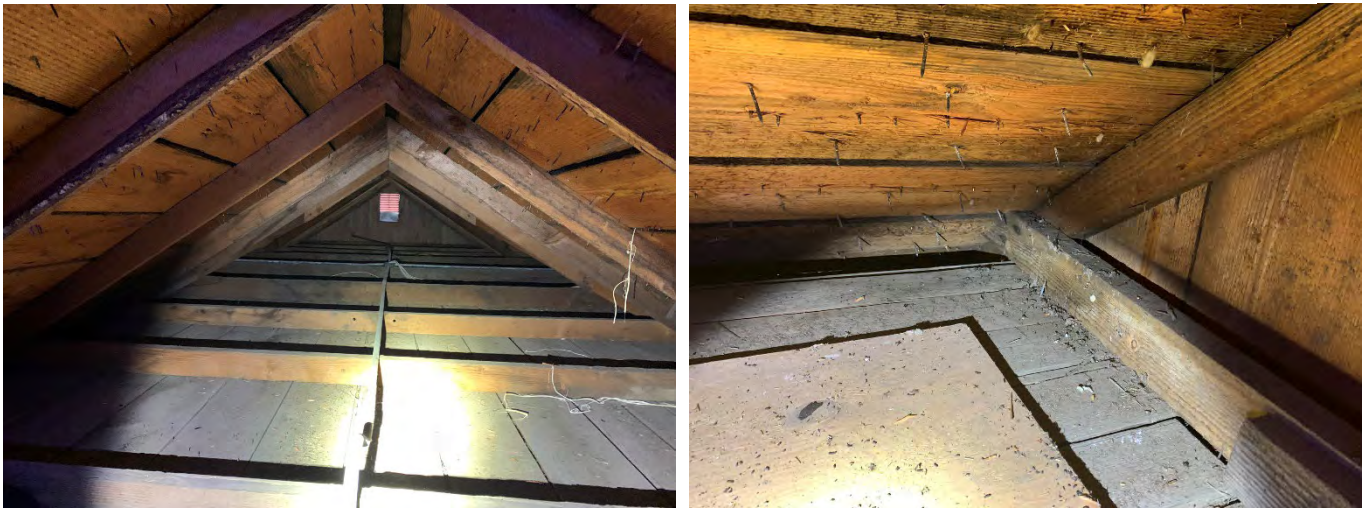
*Figure 11 - CHURCH ROOF FRAMING*

The church is roofed with cedar shakes with stainless steel flashing. See Figure 9. It appears the roof has been replaced within the last 10 years or so. The roof is in good condition. The building is equipped with aluminum gutters and they appear in good condition. Roof decking is rough sawn 1"x8" planks overlaid with tar paper when the recent cedar roof was installed. There is no evidence of rot and the planking is in good condition. The roof structure is constructed of rough cut 2"x4"'s at 24" on center. There is no ridge beam. The roof trusses are not sagging nor cracked and appear in good condition. 1"x6" planks are nailed to the underside of the trusses as sheetrock nailers. See Figure 11. There is no insulation in the attic space. The gables are covered in the original cedar board and batten. This wood is beginning to rot and should be replaced. It appears the soffits were replaced with the roof and are in good condition.

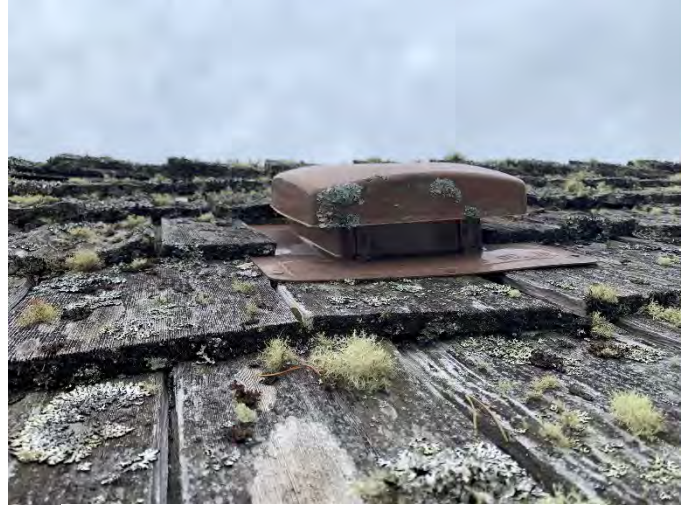
The museum building is roofed in cedar shakes which appear to date from the original construction. See Figure 10. No shakes are broken nor missing and structurally the roof appears in good condition. However, the cedar is infested with lichen and moss growth which is slowly disintegrating the wood. See Figure 13. The City should consider some preventive maintenance including moss preventative treatments to preserve the cedar shakes. There was no apparent access to the interior of the roof therefore no assessment was conducted on the roof structural framing. The building is equipped with aluminum gutters and they appear in good condition.

*Figure 13- LICHEN AND MOSS ON MUSEUM ROOF*

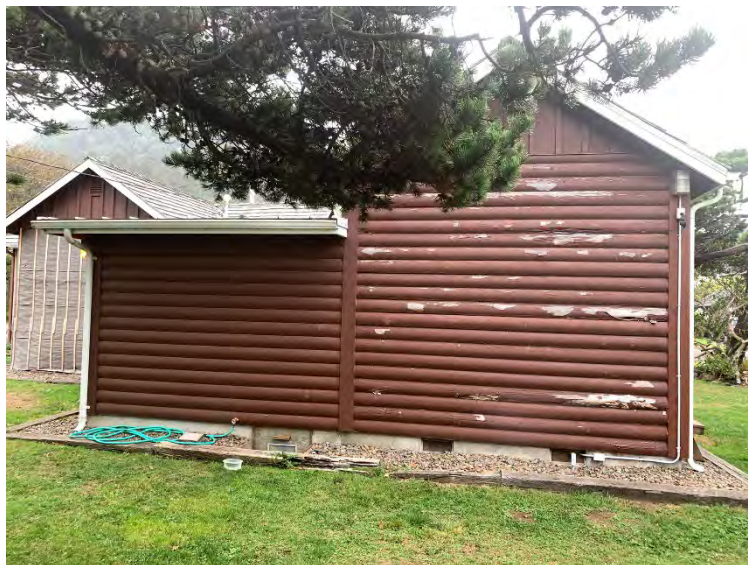
The museum and entryway, based upon their time of construction and from observations are constructed of typical lumber framing with plywood or OSB sheeting, tar paper weather covering underlayment and simulated log wood siding. From the joints in the foundation and the considerable weathering difference it is easy to see the transition between the museum addition and the bathroom addition. See Figure 17.

The siding on the bathroom addition is in good condition but the siding on the museum addition is rotten and falling apart in several places, as can be seen on the right side of the building (museum addition) in Figure 17. The tar paper underlayment is visible below the siding and appears to be untorn.

*Figure 17- TRANSITION BETWEEN BATHROOM AND MUSEUM ADDITIONS*

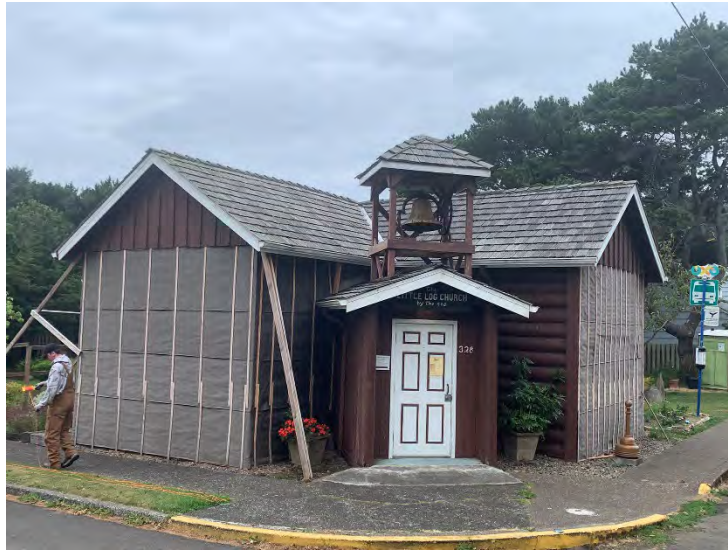
The logs on the church structure are extremely rotten in several places, in particular on the east side. See Figures 19 and 20. Large portions of the logs below and south of the east window are completely rotted away. The building is currently wrapped in tar paper and braces are supporting the north-east and south-east corners of the building. See Figure 18. Since the logs form both the structural framing and siding of the building, the braces are likely there to prevent the building from racking (tipping to the side). In typical lumber framing construction, the plywood or OSB sheathing provides protection from racking. Since this structure has no sheathing, and large portions of the logs are missing, it is possible for the building to rack in certain conditions, particularly is subjected to heavy wind loads.

Figure 18 - CHURCH STRUCTURE EAST SIDE BRACING

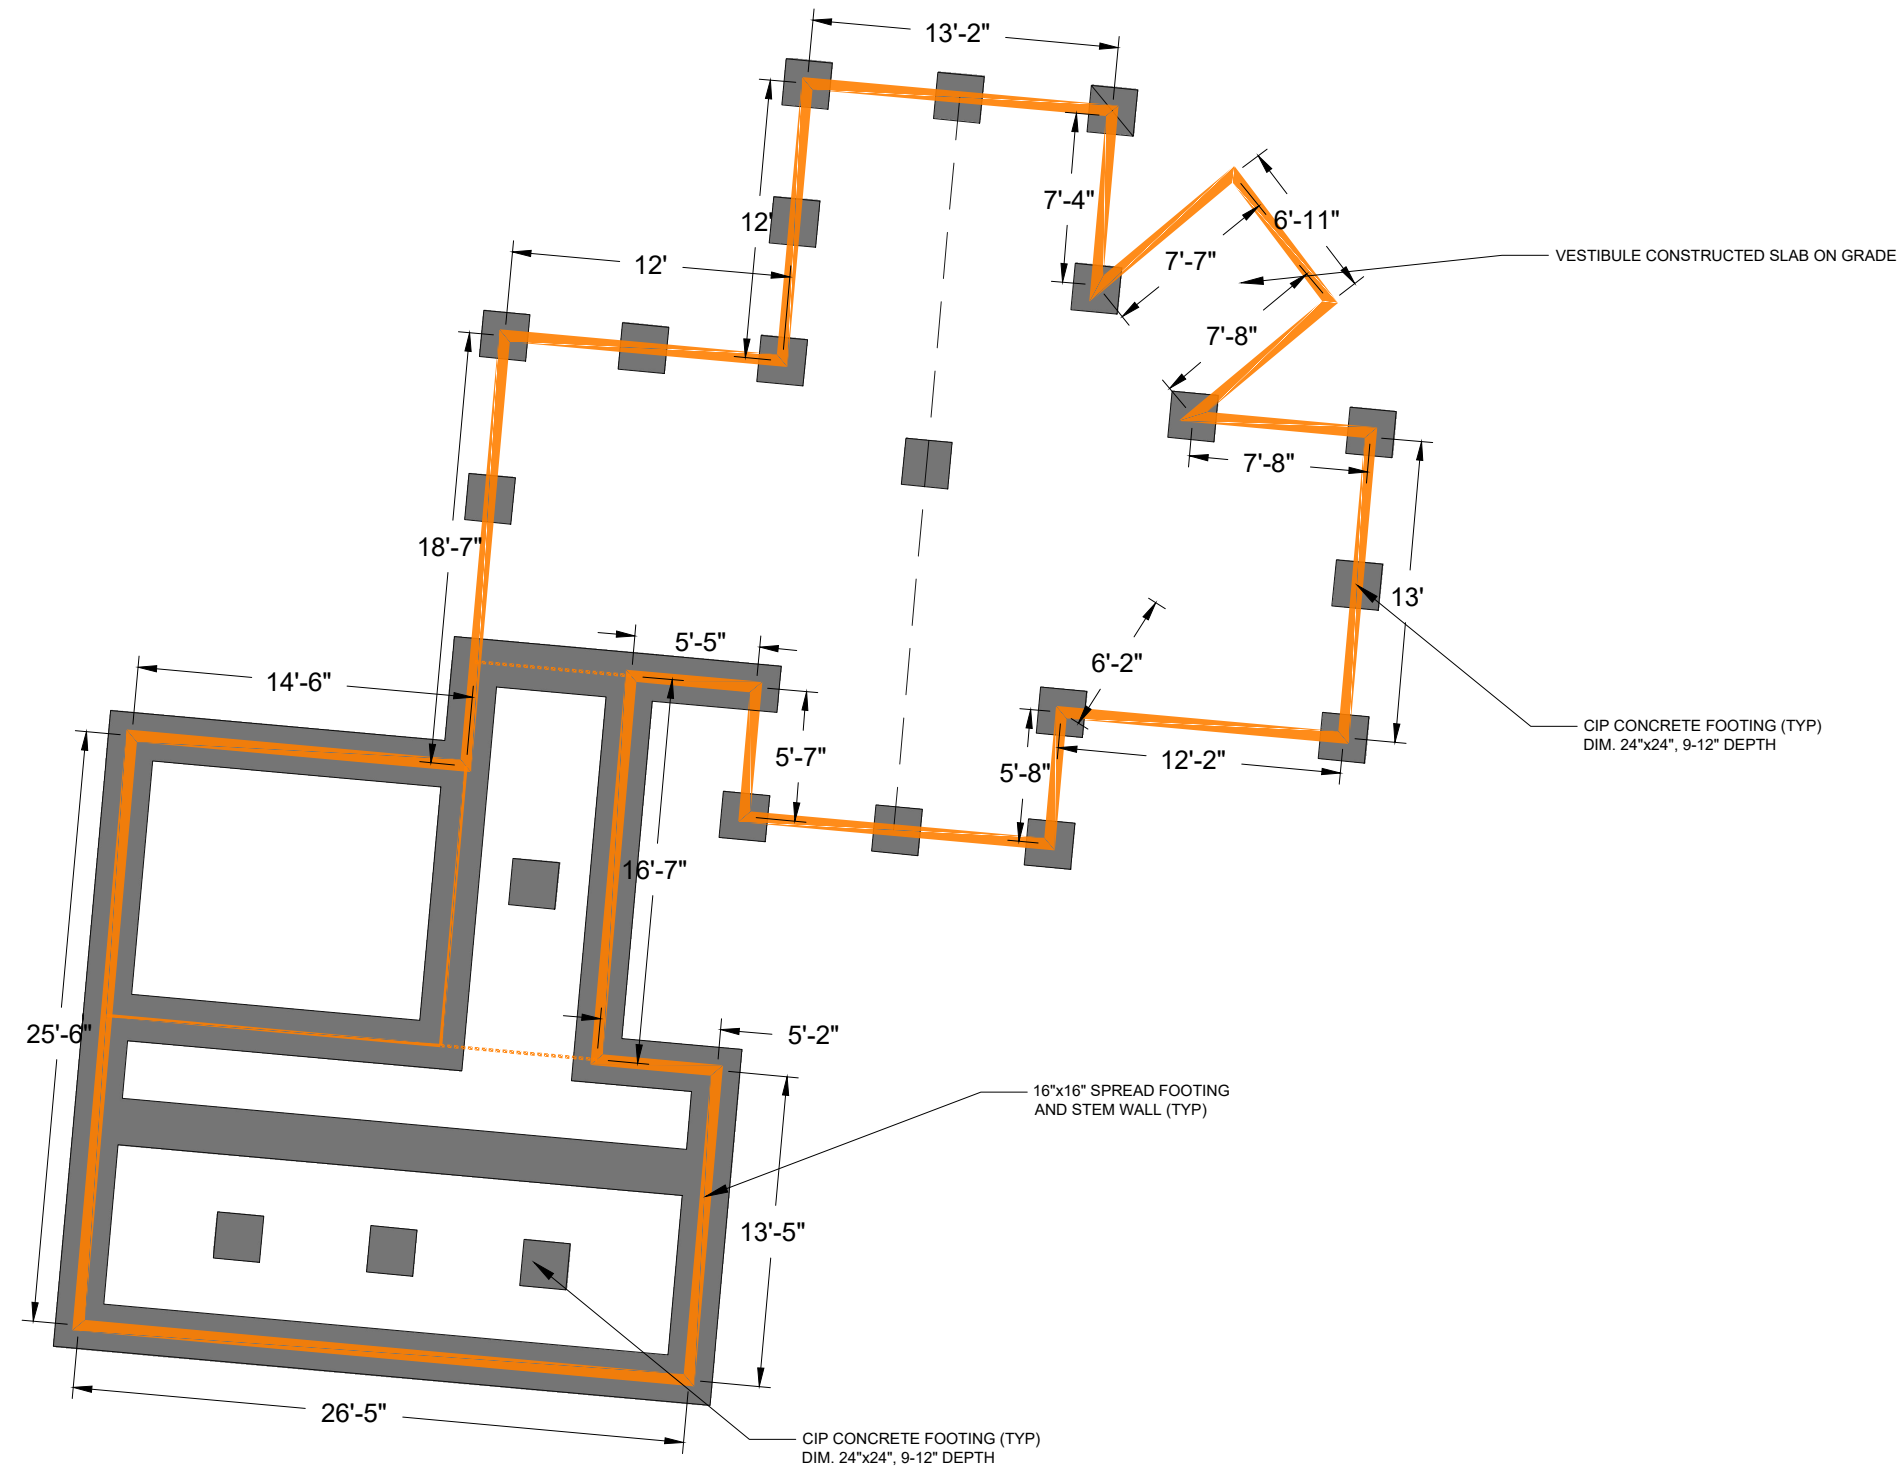
FIGURE  
2

The stem wall spread footing foundation appears in good condition. There is no evidence of settlement nor cracking. A foundation plan for the building is included as Figure 2 and in Exhibit A, Figure 2.

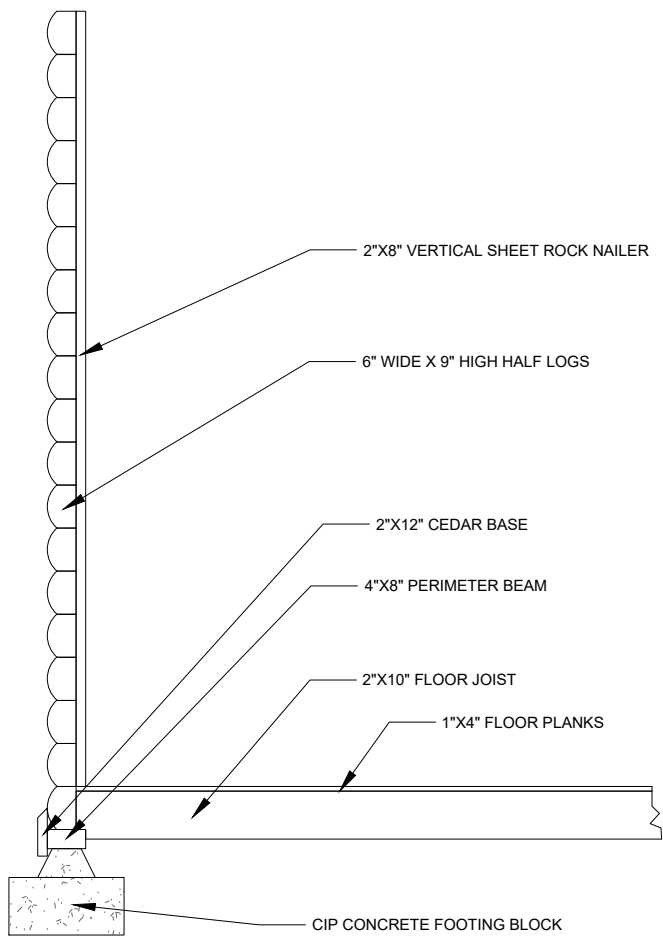
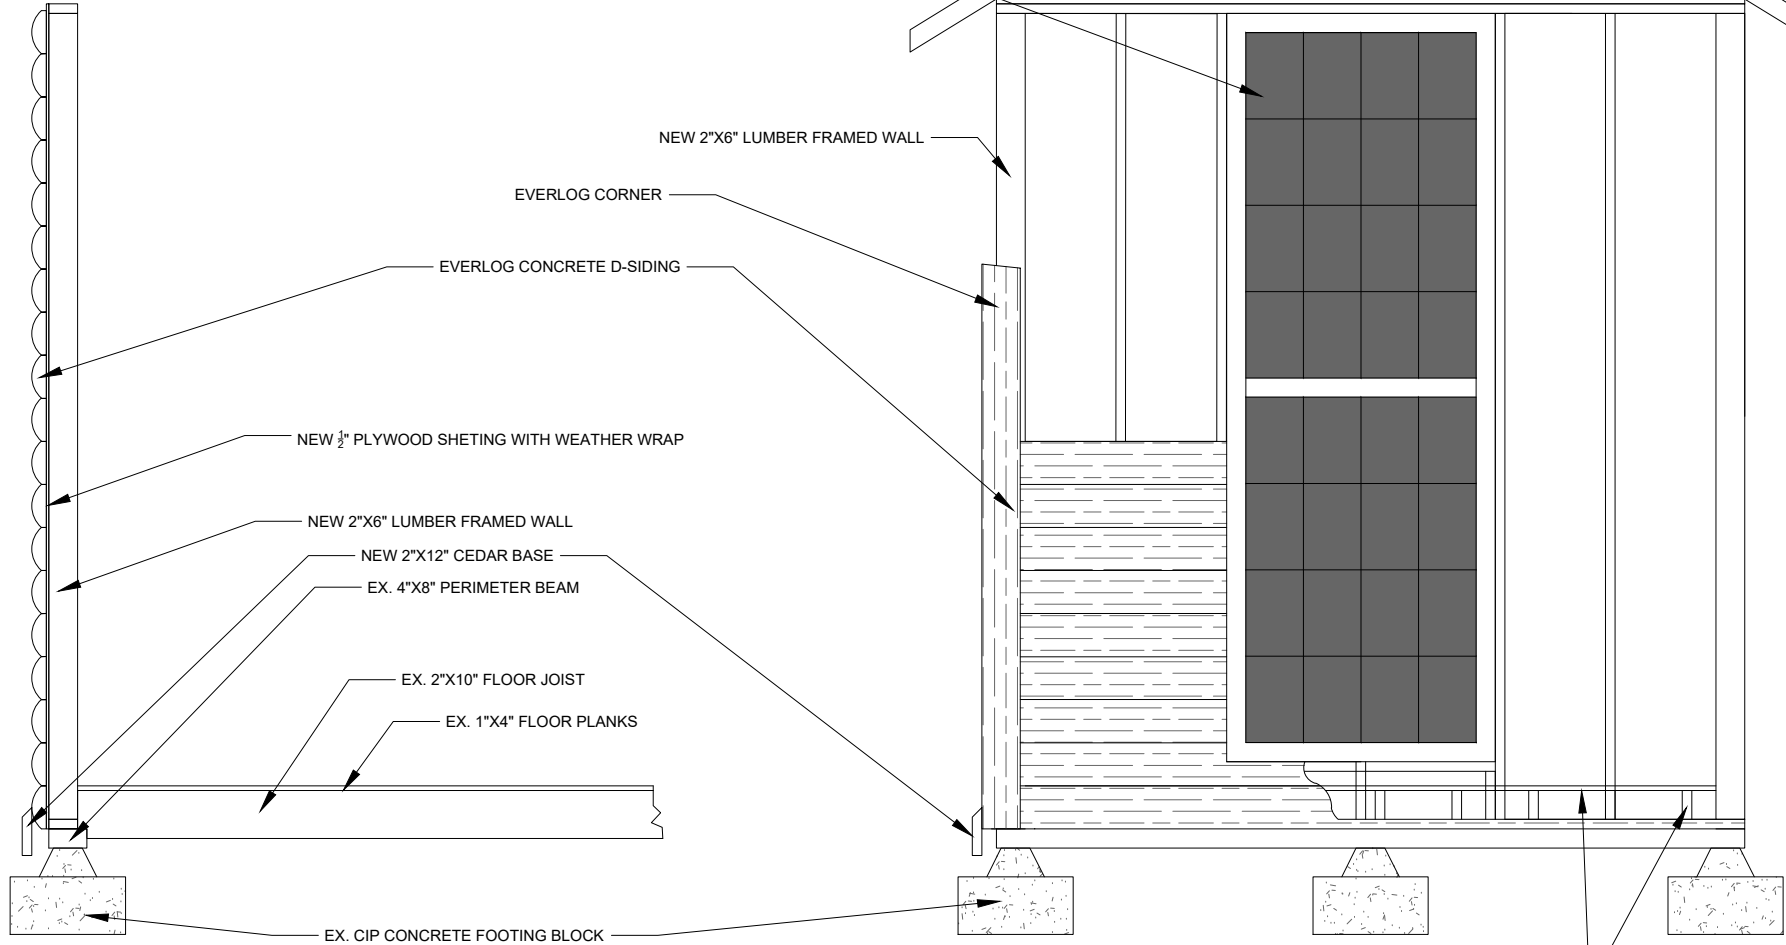
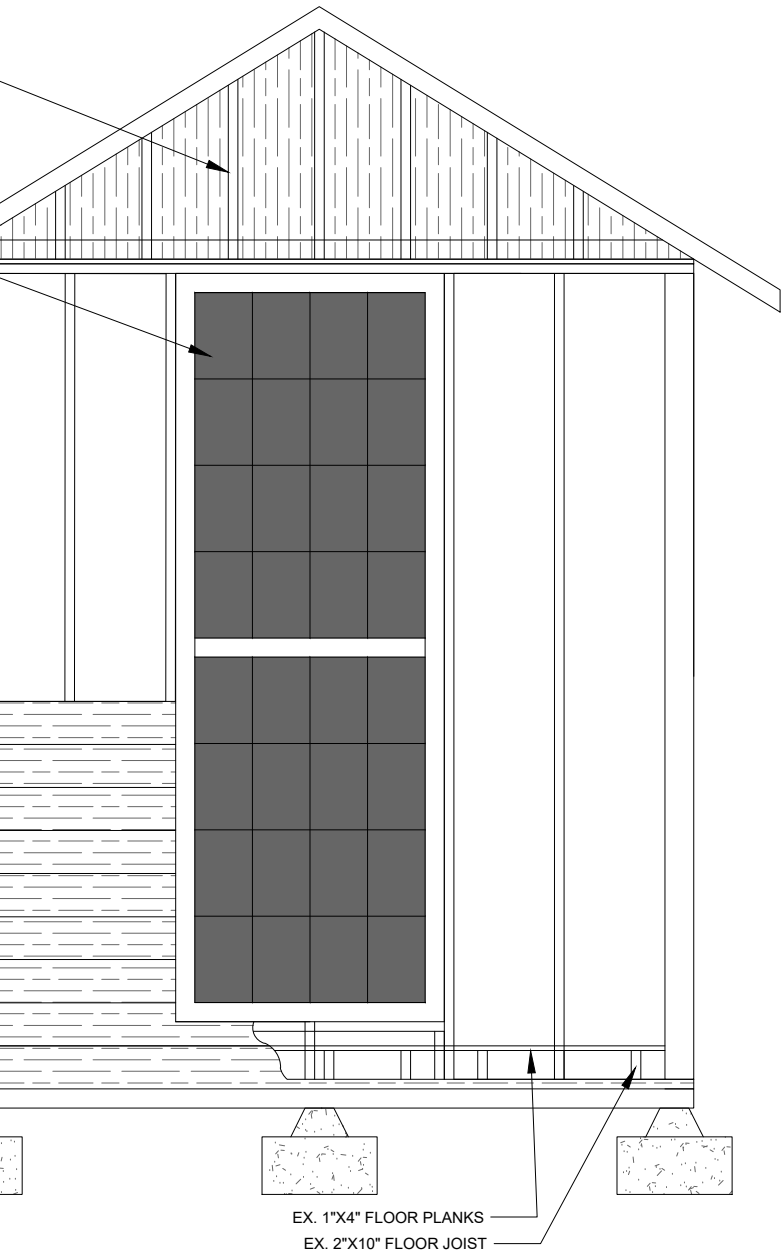
FIGURE  
7

1  
FIG7  
EXISTING WALL CONST. (CROSS SECTION)  
NTS

2  
FIG7  
PROPOSED WALL CONST.(CROSS SECTION)  
NTS

3  
FIG7  
PROPOSED WALL CONSTRUCTION (PROFILE)  
NTS

Based upon the observed condition of the building, it is recommended to replace the entire wall structure, siding, windows, and gables of the little log church, and replace only the siding of the museum. A cost estimate was prepared assuming the walls of the church will be replaced on at a time using conventional lumber framing constructed on top of the existing perimeter beam. See Table 1. It will be necessary to support the roof structure using jacks or scaffolding and the rental and installation cost for this support was considered in the cost estimate.

The museum is currently sided with “D-siding” manufactured from pine. It is called D-siding because the cross section of the siding looks like the capital letter “D.” This siding is installed over a convention lumber framed wall covered in plywood or OSB sheeting and wrapped in weather barrier paper. This is the proposed construction method for the replacement walls of the church.
